Corrosion

Official Publication
NATIONAL ASSOCIATION OF CORROSION ENGINEERS

JUNE, 1957

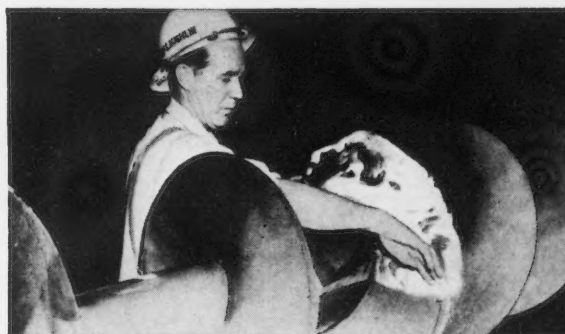
Fibrous glass cloth being applied to flight of conveyor screw which moves bleached kraft stock from washer to storage.

Lined 20 months ago with glass-reinforced LAMINAC 4119, the conveyor screw, shown here, is holding up well, no longer contaminates. Now all sewer lines are being lined with LAMINAC, while lines in a new plant under construction are to be entirely fabricated of this material. MacMillan & Bloedel has fabricated a 3-foot reinforced LAMINAC radial exhaust fan, and is covering floors and ceramic and wooden exhaust stacks with reinforced LAMINAC.

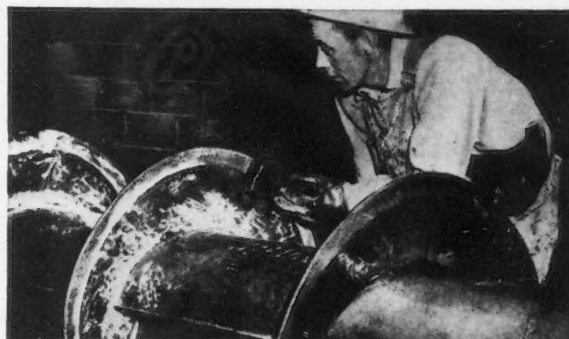
Finish coating of LAMINAC Resin is applied to conveyor screw with built-up coating of LAMINAC and glass cloth.

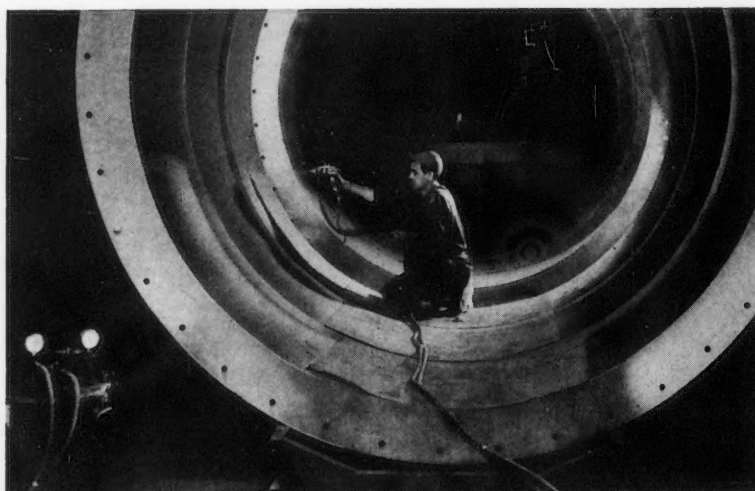
Large metal cones for storage tanks are sprayed with Unichrome "Super 5300" Plastisol Coating for protection against corrosion and abrasion. Photo Courtesy General Coating Co., Woodbridge, N.J.

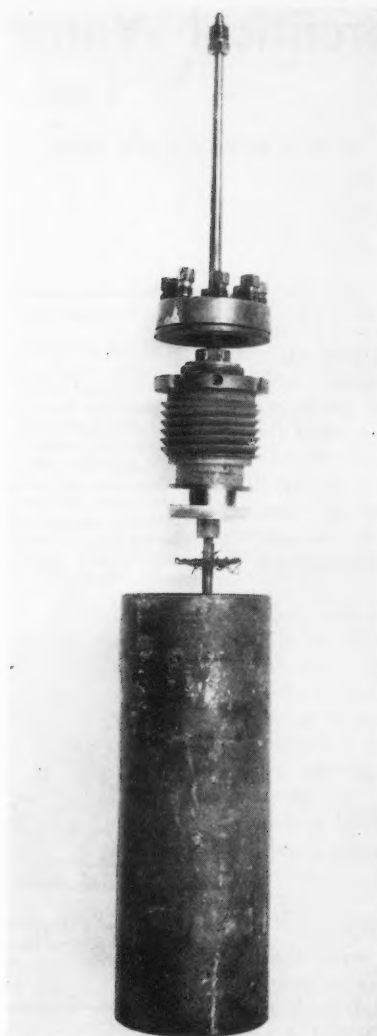
Figure 2—Exploded view of 1-liter stainless steel autoclave.

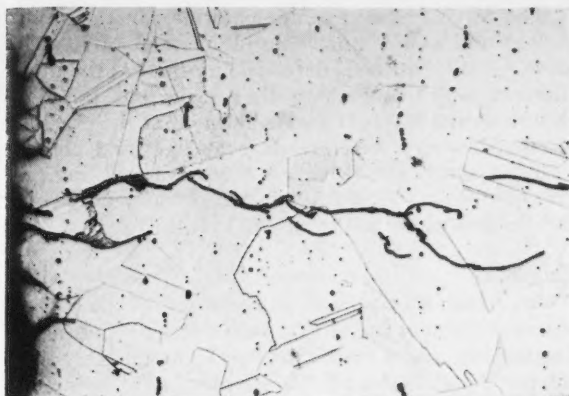
Figure 3—Cross section of stainless steel of Case 21 showing cracking. Etched with glyceregia, 100X.

Cracks extended from most of the pits. Microexamination confirmed that the cracks started from

the water side. Figure 1 shows their typical appearance. The cracks tended to spring open indicating that internal stresses were present. Slitting an uncorroded piece of the tubing showed a circumferential tensile stress of 24,000 psi.

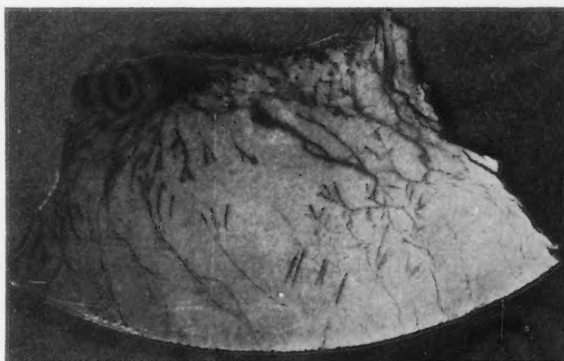
Figure 5—One of the cracked disc specimens of Case 15. 1X.

A corrosion test spool was exposed in hot levulinic acid containing some formic acid and some hydrochloric acid. When removed after one month the Type 316 stainless steel specimens on the spool were profusely cracked around the stamped identifying code letters. The cracking is shown in Figure 5.

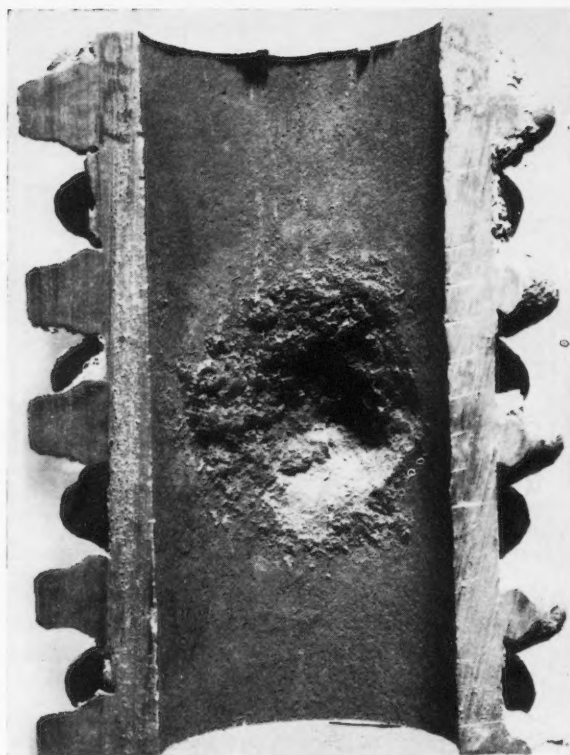
Figure 5—Characteristic tube corrosion (Photo courtesy of Hall Laboratories, Inc.).

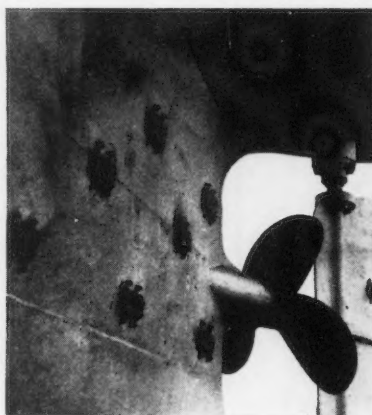
Figure 4—Installation of anodes on Navy YO Class Tanker.

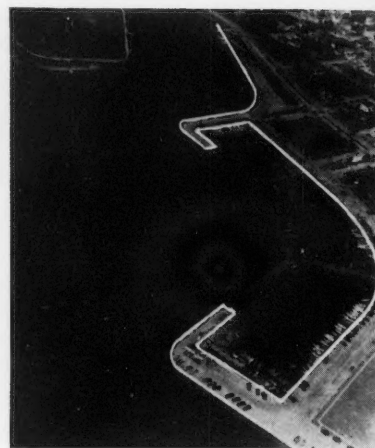
Figure 5—ASARCO Marine Test Station.

An aerial view of the Marine Test Station is shown in Figure 5. The outline of the steel bulkhead has been emphasized.

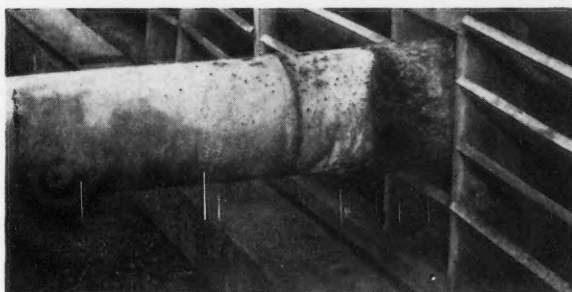
UNPROTECTED PIPE shows the effects of the corrosive action of the water splash from the cooling tower. Severe scaling and pitting are evidenced, and these pipes must be replaced. Water was highly corrosive due to acids and chemicals used for scale and algae control.

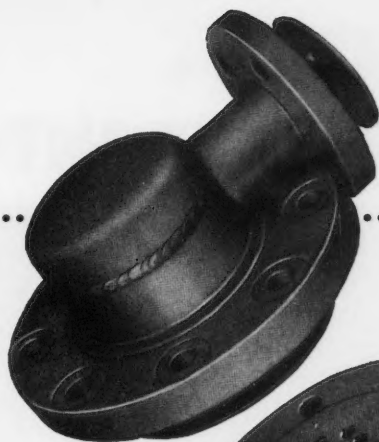
**World's First Commercial Zirconium
Heat Exchanger**—another "first" with
ZIRCONIUM by The CARBORUNDUM METALS
Company. Heat Exchanger manufactured
by Pfaudler Company.

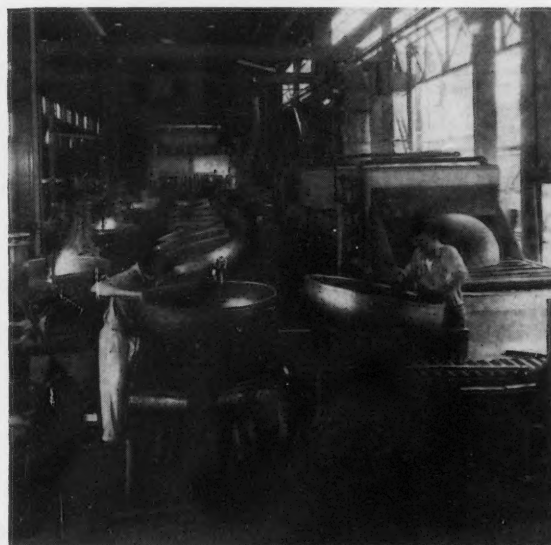
4. Claymont Stainless-Clad Steel Heads are spun or pressed in sizes up to 19 feet and in a wide variety of shapes—flanged and dished, elliptical, conical, hemispherical, etc. Shown here are two units in Claymont's extensive head-forming facilities—a large spinning machine and a new, automatic 3000-ton press.

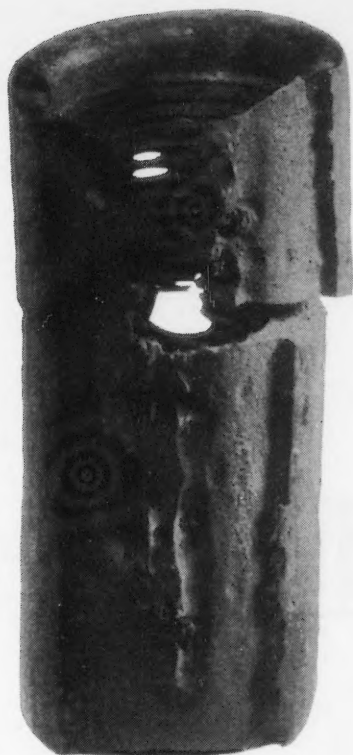
BEFORE RODINE was adopted. Note the complete breakdown of the walls of the down-well tubing and casing.

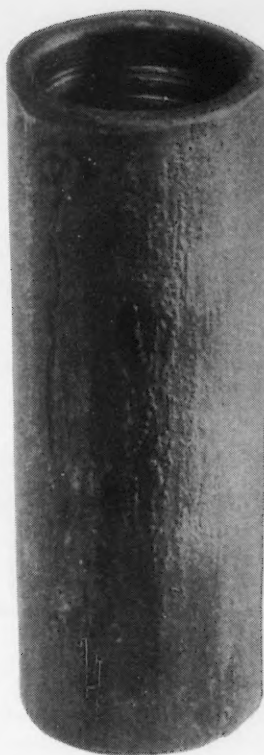
AFTER RODINE was put to use. Though the well is highly acidic, little corrosion of the tubing and casing occurs now.

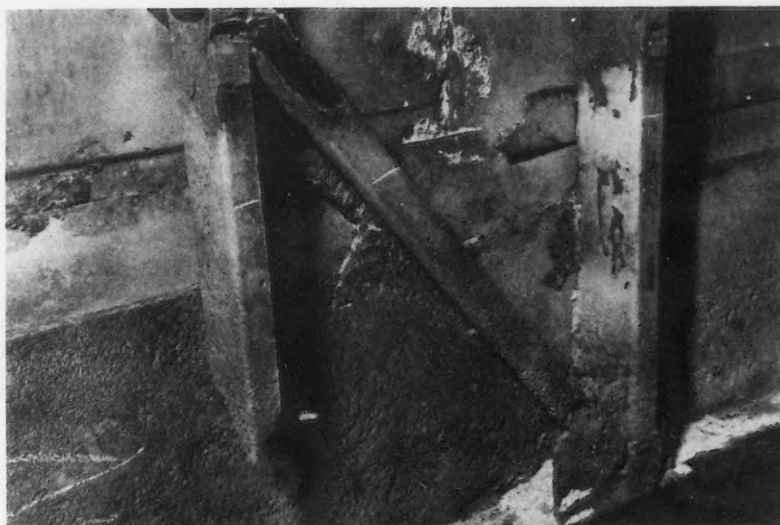
Figure 1—Corroded sills and posts in a modern diner.

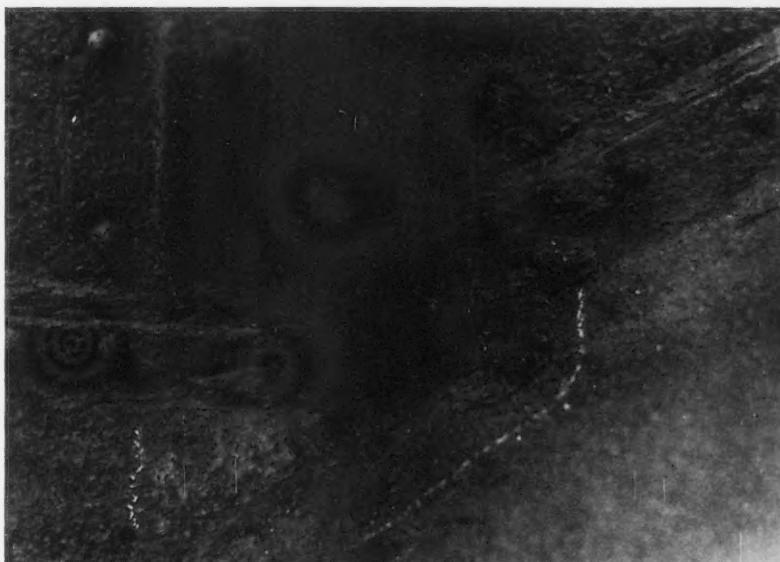
Figure 2—Severe corrosion found at slope sheet ridges on common hopper cars.
